# Manhole Inspection Summary

Manhole # S39AA1008MH

**Location** Address: **3318 ELLERSLIE AVE**

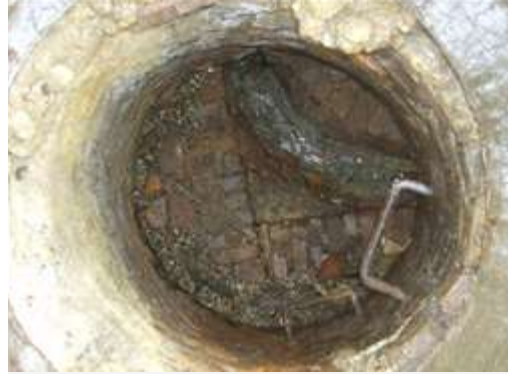
Top View

Corroded steps. Evidence of surcharge - Bench debris.

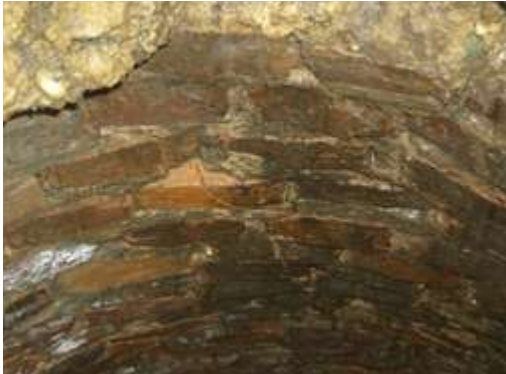
Defect

Corbel deterioration and infiltration.

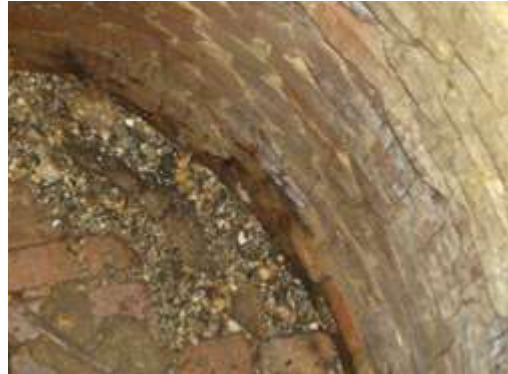
Defect

Barrel infiltration and deterioration.

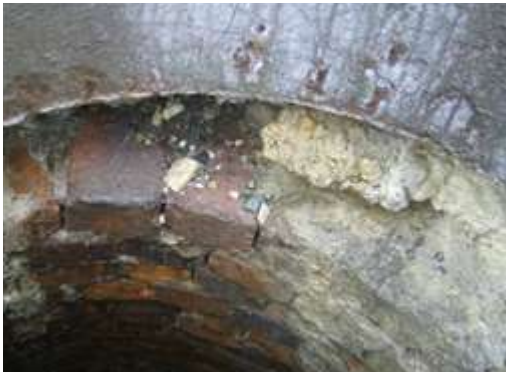
Defect

Frame offset. Frame leaks. Adjustment and Corbel deterioration and infiltration.

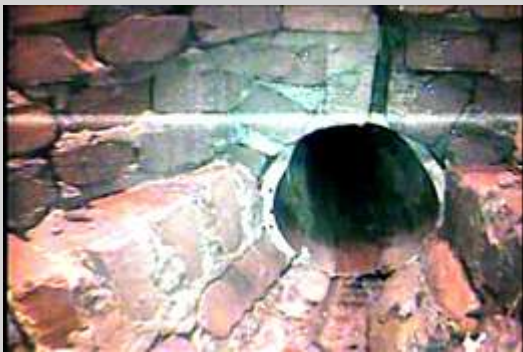
### 8 in. Circular Gravity Sewer Pipe Out @ 12 O'Clock

Barrel deterioration and infiltration. Channel deterioration.

Infiltration: **None** Pipe Seal Cond: **Broken**

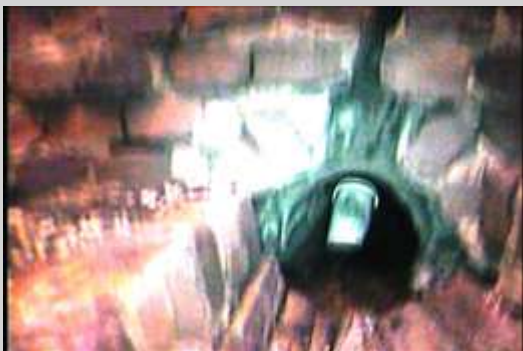
### 8 in. Circular Gravity Sewer Pipe In @ 3 O'Clock

Barrel deterioration and infiltration. Channel deterioration.
